# Lessons Learned from the Façade Fiasco

Dr. Jonathan Barnett

*Technical Director, RED Fire Engineers*

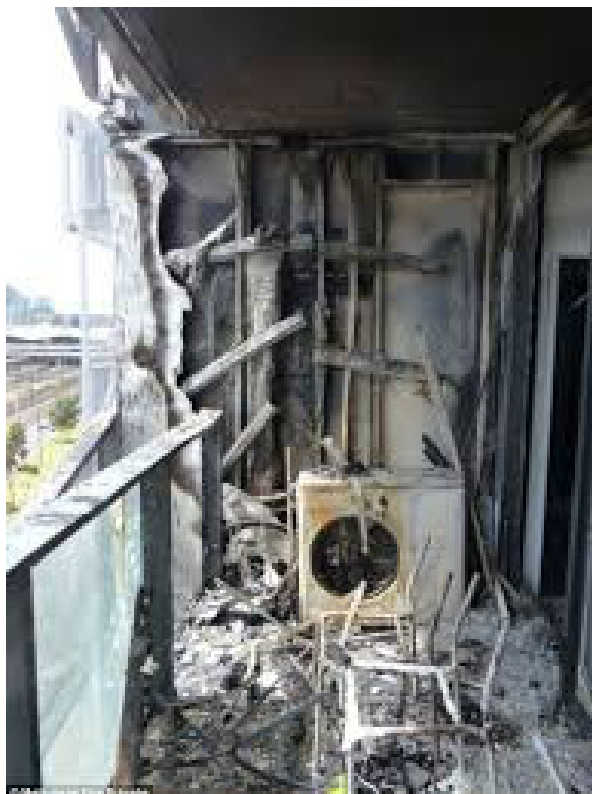
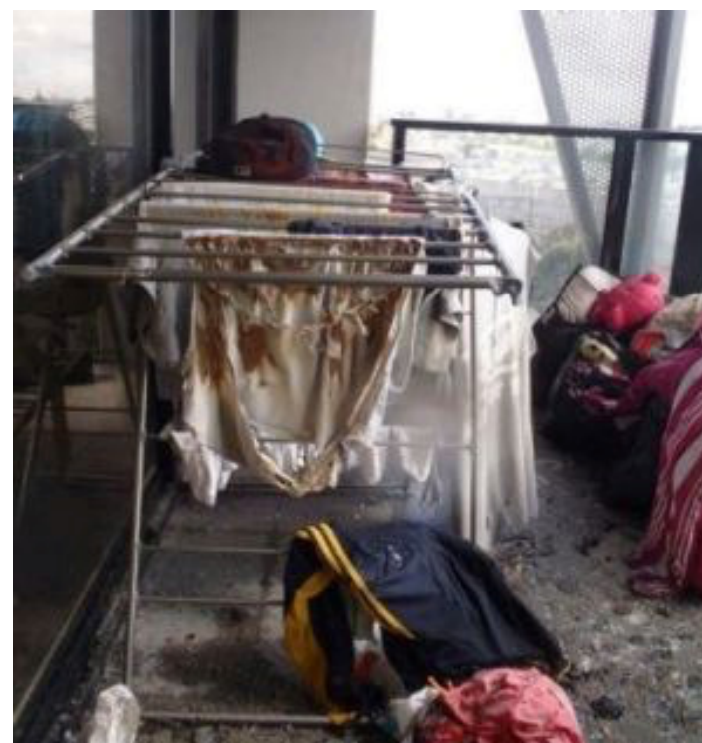
# Balcony of origin

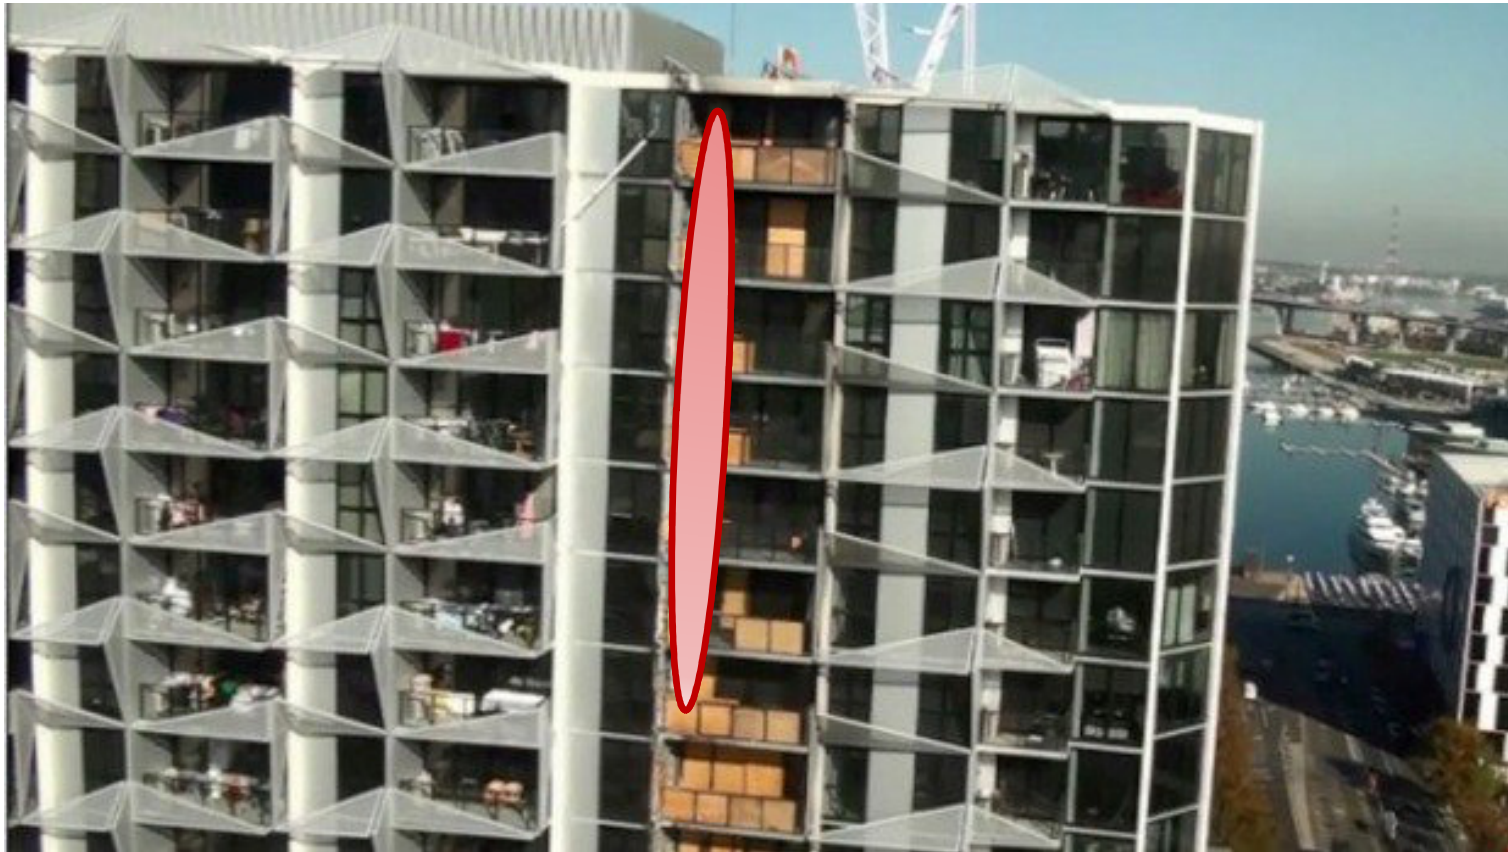
# Vertical path of fire spread

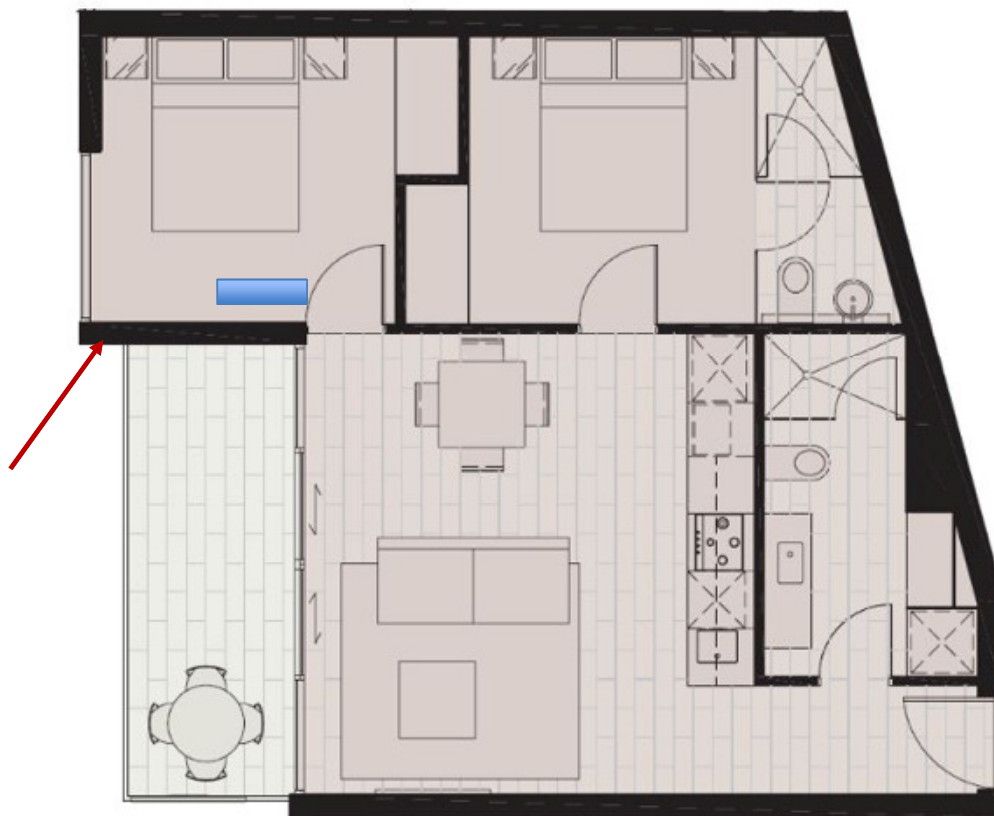
# Spread up this panel

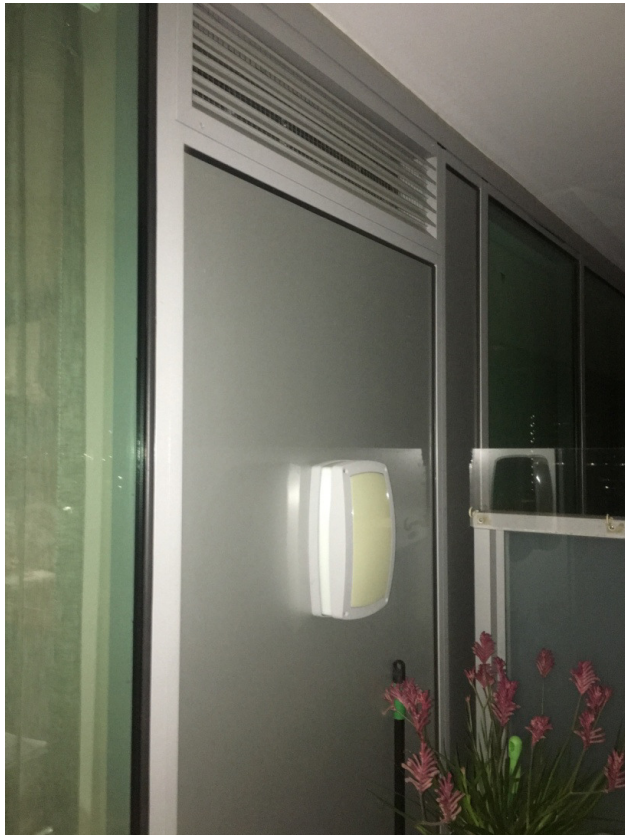
# The balcony attachment

- Above the ACP panel is the grill for the bathroom and kitchen exhausts.

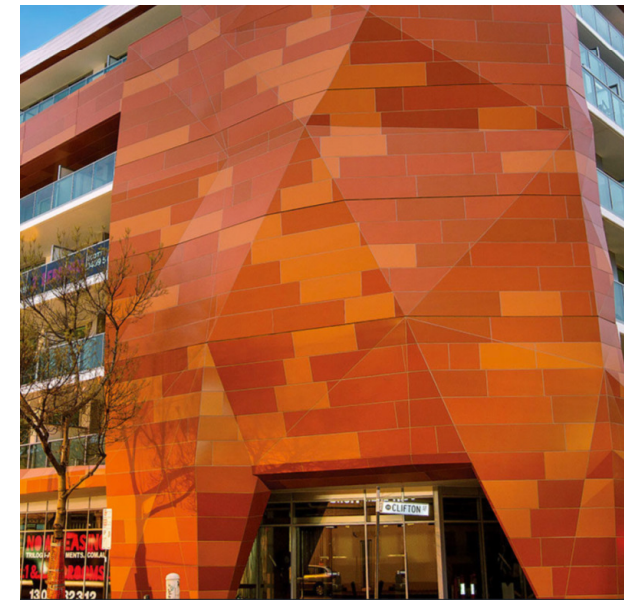
# External Wall

- Even if the Vitrabond is an attachment, the PIR is part of the wall
- The PIR is combustible
- Therefore the wall is not compliant with the DtS provisions.
- Learning from Grenfell, it is non-compliant from a performance viewpoint.
